# Senior Activity Center Montpelier, VT

## City of Montpelier ADA Transition Plan

November 2018

## Senior Activity Center, Montpelier, VT

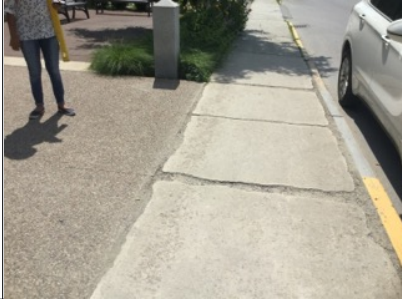
Surface openings > 1/2"	-	Patch opening in concrete.  (Cost for a concrete patch.)	1	309	\$309
<b>Off-Street Parking Lot or Garage</b>												
2	Parking East Side of Building	Ext.		Off-Street Parking Lot or Garage	N/A

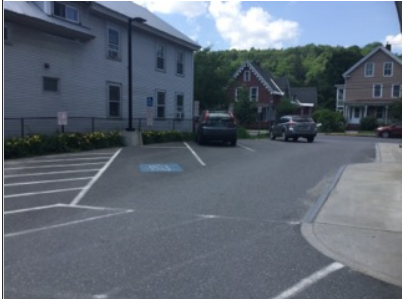
Total # of parking Total # of designated accessible parking spaces Total # of designated van accessible spaces Sign does not have the designation "Van Accessible"	28 3 1 -	Add the designation "Van Accessible" to the sign located at the van accessible space positioned 60" min. above the ground.	1	250	\$250
<b>Access to Goods and Services</b>												
<b>Means of Egress</b>												
3	Barre Street Entrance	1		Means of Egress	N/A

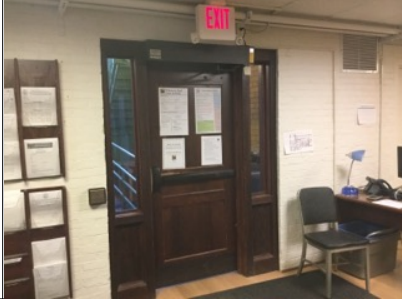
Tactile exit sign not provided	-	Ensure tactile exit signs with raised characters and braille are provided at this and four other egress doors (one egress door is on the second floor.) Mount signs between 48"- 60" above finish floor located on the latch side of the door.	5	116	\$580

Accessibility issues include lack of tactile signs (5) at egress doors.

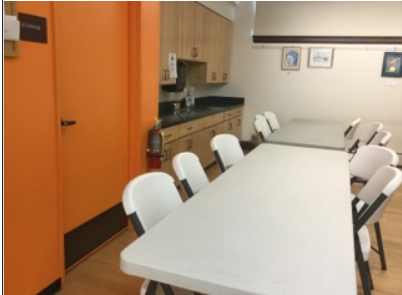
<b>Interior Access Route</b>												
4	Dining Area	1		Interior Access Route	N/A

Route < 36" wide	25"	Ensure that a clear width of 36" min. is maintained at the accessible route between the dining table and the kitchen.	1	Labor	\$0

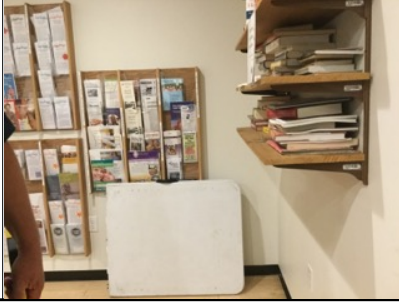
ID	Location	Floor	Room	Element	Type	Photo	Issues	Current Measure	Recommendations	Quantity	Price	Cost Estimation
5	Resource Room	1		Interior Access Route	N/A

Obstructed by protruding objects	43"	Provide a cane detectible barrier.	1	153	\$153
<b>Doors, Doorways, &amp; Gates</b>												
6	Men's and Women's Multi-User Toilet Rooms	1		Doors, Doorways, & Gates	Toilet Room

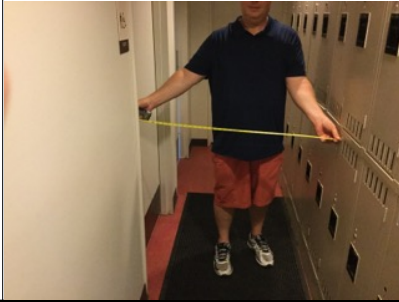
Maneuvering clearance(s) not provided	38"	Remove lockers across from men's and women's multi-user toilet room doors to maintain 42" min. maneuvering space.	2	918	\$1836
7	Men's Multi-User Toilet Room	1		Doors, Doorways, & Gates	Toilet Room

Accessibility issues include lack of required maneuvering clearance (38") at the entry doors to the men's and women's multi-user toilet rooms on the first floor, excessive opening force at the door to men's multi-user toilet room, malfunctioning self-closing hinge at door to men's multi-user toilet room accessible

- Provide required maneuvering clearance at entry doors to the men's and women's multi-user toilet rooms: \$1,836
- Miscellaneous corrective measures (excessive openings in sidewalk, etc.): \$1,434

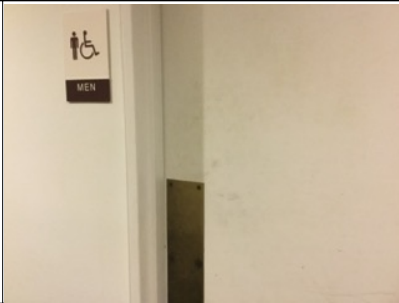
Door requires > 5 lbs. of force to open	18 lbs.	Adjust closer so door does not require more than 5 pounds of force to open.	1	Labor	\$0
<b>Ramps</b>												
8	Inside Barre Street Entrance	1		Ramps	Interior

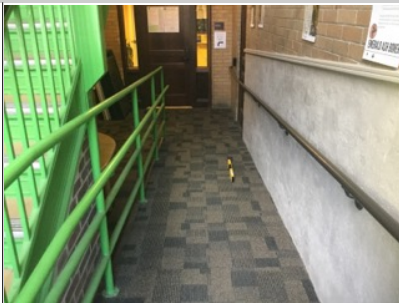
Handrails < 34" or > 38" above ramp surface.	42"	Alter so the handrails are 34"- 38" high above the finish floor.	1	Labor	\$0

Accessibility issues include handrails on one side of the interior ramp at the Barre Street entrance that are both lower (31") and higher (42") than required.

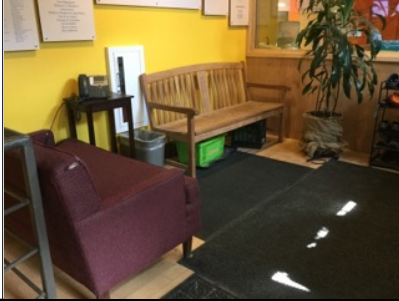
20% of benches have clear space < 36" x 48"	-	Ensure that 20% of benches (and at least one) have a clear floor space of 36" wide min. by 48" deep min.	1	Labor	\$0
<b>Toilet &amp; Bathing Rooms</b>												
<b>Lavatory</b>												
11	Single-User Toilet Room	2		Lavatory	N/A

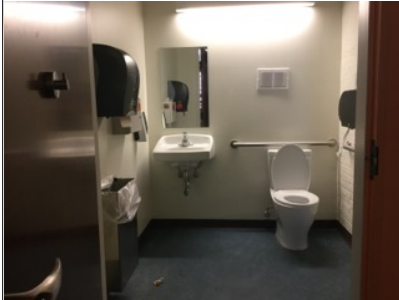
Plumbing underneath is exposed Door has malfunctioning self closing hinge.	-	Insulate or otherwise configure pipes to prevent contact at lavatory. Repair self closing hinge.	1	46	\$46
<b>Toilet Compartment</b>												
12	Men's Multi-User Toilet Room	1		Toilet Compartment	Accessible Compartment

compartment, and exposed plumbing at the lavatory in the single-user toilet room on the second floor.
