Police Station Montpelier, VT

City of Montpelier ADA Transition Plan

November 2018

Police Station, Montpelier, VT

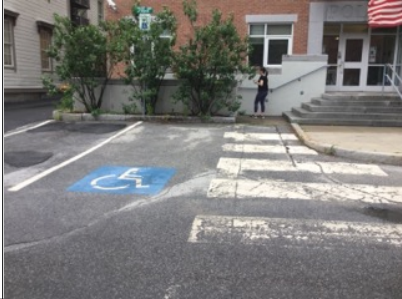
Accessibility issues include lack of a van-accessible parking space and access aisles that have excessive running and cross slopes (5.5%).

ID	Location	Floor	Room	Element	Type	Photo	Issues	Current Measure	Recommendations	Quantity	Price	Cost Estimation
Approach and Entrance												
Off-Street Parking Lot or Garage												
1	Parking	Ext.		Off-Street Parking Lot or Garage	Visitor

Total # of parking Total # of designated accessible parking spaces Total # of designated van accessible spaces Running or cross slope at space > 1:50 (2.00%) Running or cross slope at access aisle > 1:50 (2.00%) Sign does not have the designation "Van Accessible"	4 1 - 5.5% 5.5% -	Re-stripe to provide a van accessible parking space and access aisle. Include sign with the phrase "Van Accessible" positioned 60" min. above the ground. Clear branches from existing sign with the International Symbol of Accessibility, reduce running and cross slope at space and access aisle to be no steeper than 1:50 (2.00%) in all directions.	1	438	\$438
Access to Goods and Services

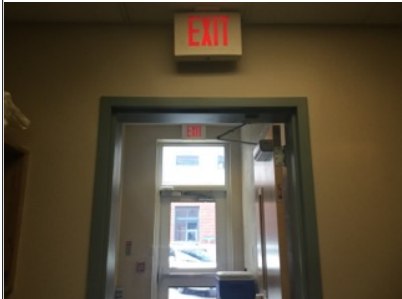
Means of Egress												
2	Across From Elevator Restricted Area	1		Means of Egress	N/A

Tactile exit sign not provided	-	Ensure tactile exit signs with raised characters and braille are provided at exit doors. Mount signs between 48"- 60" above finish floor located on the latch side of the door.	2	116	\$232
3	Lobby	1		Means of Egress	N/A

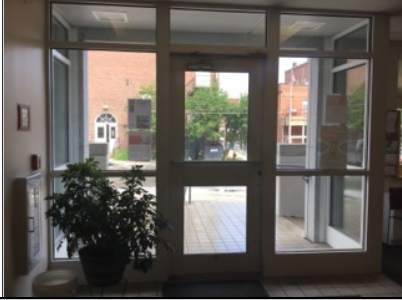
Tactile exit sign not provided	-	Ensure tactile exit signs with raised characters and braille are provided at exit doors. Mount signs between 48"- 60" above finish floor located on the latch side of the door.	1	116	\$116
Interior Access Route												
4	Outside Restricted Area	1		Interior Access Route	N/A

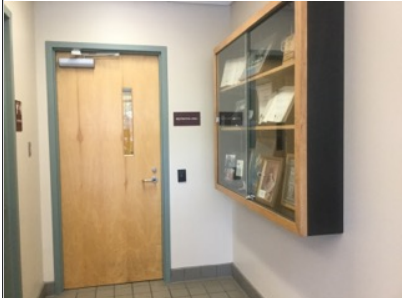
Obstructed by protruding objects	9"	Provide a cane detectable barrier.	1	153	\$153

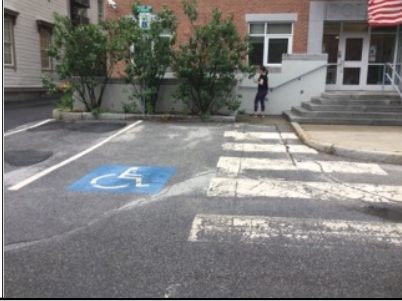
ID	Location	Floor	Room	Element	Type	Photo	Issues	Current Measure	Recommendations	Quantity	Price	Cost Estimation
Signage												
5	Parking	Ext.		Signage	Designation

International Symbol of Acc. not compliant	-	International Symbol of Accessibility sign obstructed by tree branches. Trim branches to make sign visible.	1	100	\$100
Service Counter												
6	Lobby	1		Service Counter	N/A

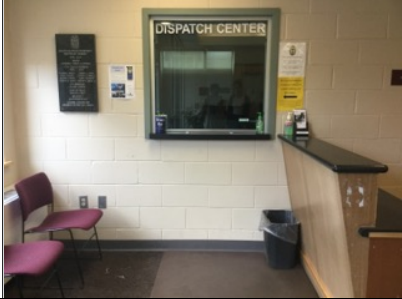
Accessibility issues include lack of an accessible service counter.

Counter > 36" high	41"	Provide a counter that is 36" max. above the finish floor.	1	440	\$440
Detention Facilities												
7	Holding Cell	1		Detention Facilities	Other

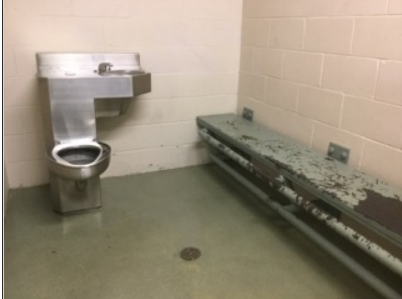
Accessibility issues include lack of side and rear grab bars at the toilet in the detention cell with the required clear floor space (has water fountain).

< 3% of holding cells have mobility features	-	Provide a side wall grab bar that is 42" long min. located 12" max. from the rear wall. Provide a rear wall grab bar that is 42" long min. and extends from the toilet 12" min. on one side and 24" min. on the open side (transfer side). Mount grab bars 33" min. and 36" max. above the floor.	1	898	\$898

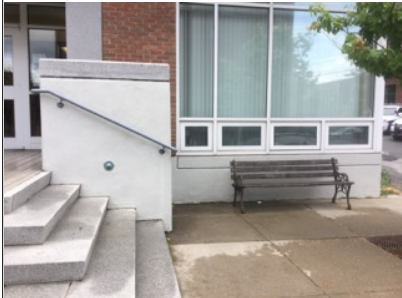
Benches												
8	Main Entrance	Ext.		Benches	N/A

No accessible route to 20% of benches	-	Relocate 20% of benches (at least 1) on an accessible route.	1	Labor	\$0
Toilet & Bathing Rooms

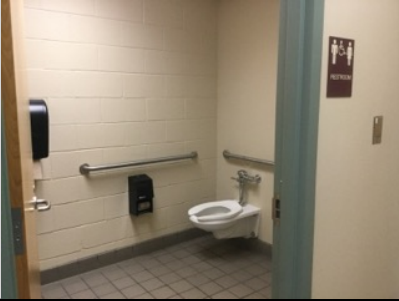
ID	Location	Floor	Room	Element	Type	Photo	Issues	Current Measure	Recommendations	Quantity	Price	Cost Estimation
Overall Access												
9	Toilet Room	1		Overall Access	Toilet Room

Audible and visible alarms not provided	-	When fire system is updated, ensure that a visible and audible fire alarm is installed.	1	346	\$346
Single-User Toilet												
10	Toilet Room	1		Single-User Toilet	N/A

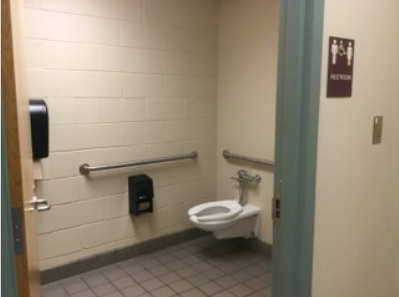
Accessibility issues include a flush control that is not on the open or transfer side, and lack of a visible and audible alarm.

Flush control not on open side	-	Relocate the flush control to the open side.	1	187	\$187
