# Fire Station Montpelier, VT

## City of Montpelier ADA Transition Plan

September 2018

## Fire Station, Montpelier, VT

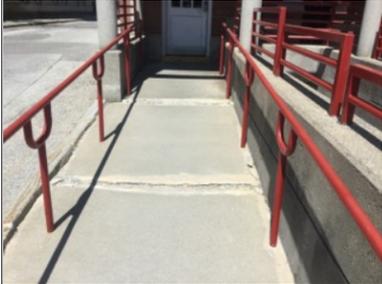
There are surface openings in excess of 1/2" on the exterior ramp leading to the accessible entrance.

ID	Location	Floor	Room	Element	Type	Photo	Issues	Current Measure	Recommendations	Quantity	Price	Cost Estimation
<b>Approach and Entrance</b>												
<b>Exterior Access Route</b>												
1	Main Entrance	Ext.		Exterior Access Route	Exterior

Surface openings > 1/2"	3"	Repair so that openings are 1/2" max. and the long opening dimension is perpendicular to the dominant direction of travel.	2	103	\$206
<b>Best Practice</b>												
2	Parking Lot	Ext.		Best Practice	N/A

- Miscellaneous corrective measures (repair exterior ramp surface, provide signs with raised characters and Braille at egress doors, insulate pipes at the lavatory in each toilet room, provide signage at the multi-user toilet rooms upstairs to the accessible toilet room on the first floor, provide continuous handrails on both sides of interior stairs, etc.):  
\$1,468

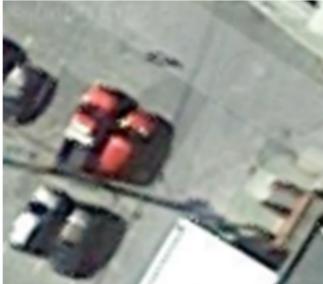
Accessible parking not provided near the accessible entrance.		Consider providing a van accessible space with marked access aisle and sign including the International Symbol of Accessibility and words 'Van Accessible' positioned 60" min. above the ground located on the closest accessible route from the parking area to the accessible entrance at the Fire Station.	1		\$0
<b>Access to Goods and Services</b>

- Recommend providing at least one accessible parking space near the accessible entrance at the Fire Station.

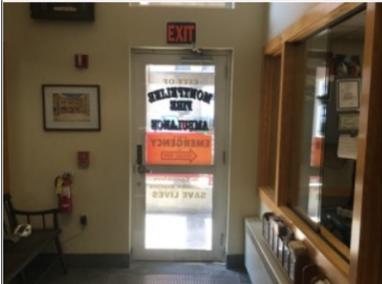
<b>Means of Egress</b>												
3	By Reception	1		Means of Egress

Tactile exit sign not provided	-	Ensure tactile exit signs with raised characters and braille are provided at exit doors. Mount signs between 48"- 60" above finish floor located on the latch side of the door.	1	116	\$116
4	Stairs	2		Means of Egress

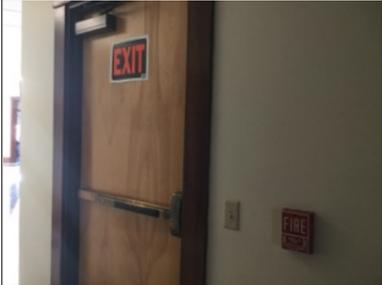
Tactile exit sign not provided	-	Ensure tactile exit signs with raised characters and braille are provided at exit doors leading to enclosed stairways. Mount signs between 48"- 60" above finish floor located on the latch side of the door.	1	116	\$116

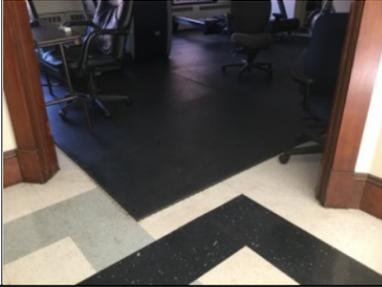
There is no accessible route to the second floor of the Fire Station where two rooms used for CPR and similar classes are located.

ID	Location	Floor	Room	Element	Type	Photo	Issues	Current Measure	Recommendations	Quantity	Price	Cost Estimation
<b>Interior Access Route</b>												
5	Gym/CPR Classes	2		Interior Access Route	N/A

Level changes > 1/4"	1"	Relocate class to alternate location in kitchen where entrance is accessible or from the second floor to an alternate accessible location as needed.	1	0	\$0
<b>Stairways</b>												
6		2		Stairways	Interior

*Note: There is not an accessible vertical route at the Fire Station. IHCD recommends relocating the classes held on the second floor as needed.*

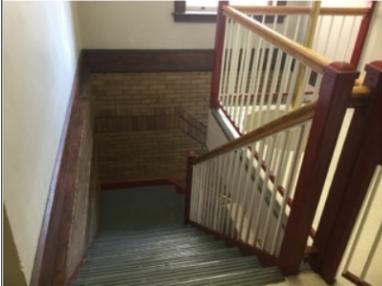
Handrails are not continuous on both sides.

Handrail not provided on both sides Handrails not continuous where required	- -	Provide handrail on one side. Provide continuous handrails.	1	660	\$660
<b>Signage</b>												
7	Women's Toilet Room	2		Signage	Designation

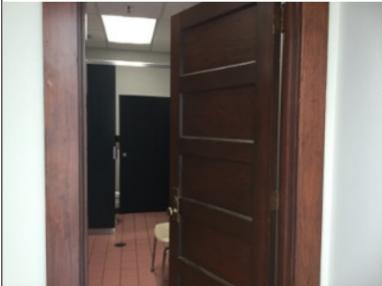
Not provided Raised characters not provided Braille not provided Sign not located on the latch side of the door Directional sign to access. toilet not provided	- - - - -	Locate signage alongside the door on the latch side. Provide text with raised characters duplicated in braille. Provide a sign indicating the location of the nearest accessible toilet room.	1	116	\$116

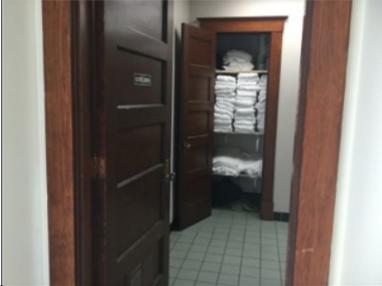
8	Men's Toilet Room	2		Signage	Designation

Raised characters not provided Braille not provided Sign not located on the latch side of the door Directional sign to access. toilet not provided	- - - -	Provide text with raised characters duplicated in braille. Locate sign at permanent rooms alongside the door on the latch side. Provide a sign indicating the location of the nearest accessible toilet room.	1	116	\$116
<b>Toilet &amp; Bathing Rooms</b>

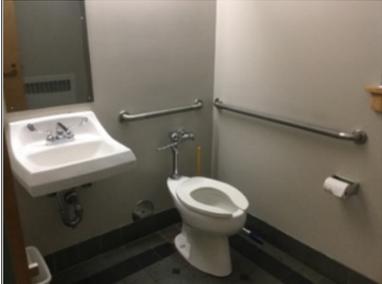
The single-user toilet room on the first floor and both multi-user toilet rooms on the second floor lack insulated pipes at the lavatory. On the second floor, the multi-user women's toilet room lacks signage, the multi-user men's toilet room lacks signage with raised characters and Braille, and both second-floor toilet rooms lack signage directing users to the accessible toilet room on the first floor.

ID	Location	Floor	Room	Element	Type	Photo	Issues	Current Measure	Recommendations	Quantity	Price	Cost Estimation
Lavatory												
9	Reception Toilet Room	1		Lavatory

Plumbing underneath is exposed	-	Insulate or otherwise configure pipes to prevent contact, for at least one lavatory in all three toilet rooms (first and second floor).	3	46	\$138
